Insurance Condition Survey

“SIROCCO”

Inspection date:
14th June 2020

MSES Case No:
201287HK

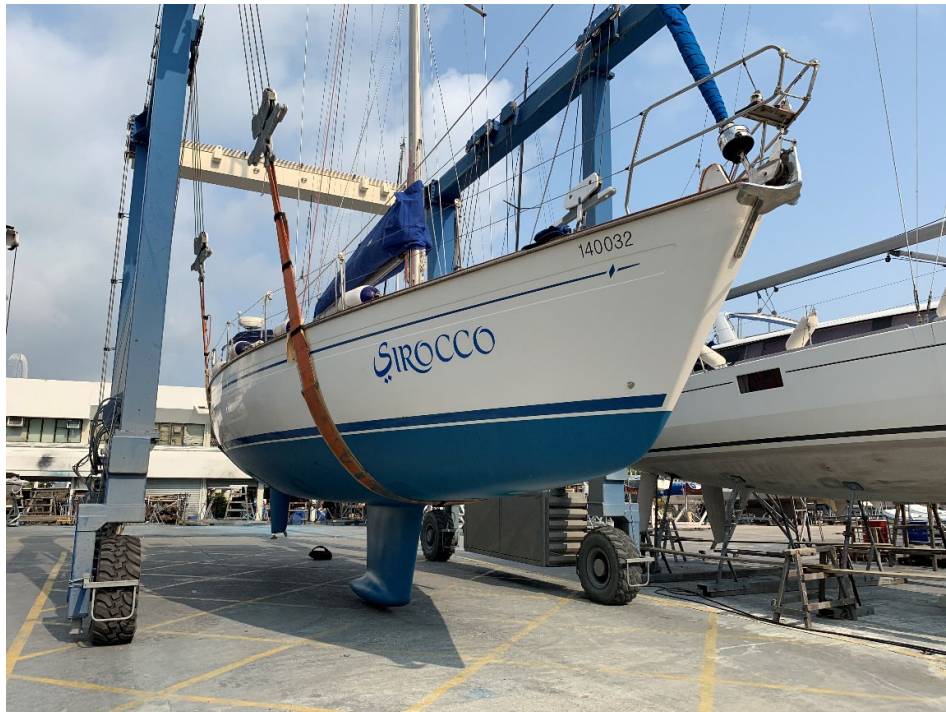
Sirocco in the travel hoist at Royal Hong Kong Yacht Club

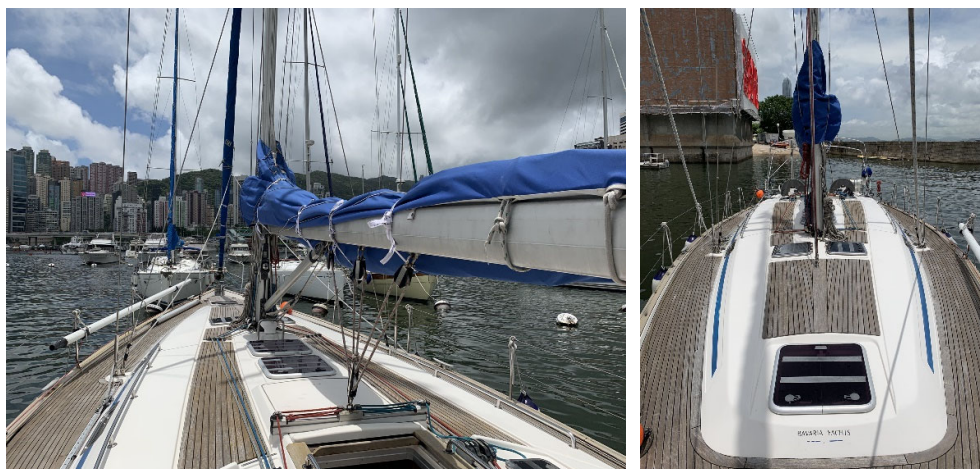
Deck

STEM:	Good condition – Was strengthened in 2016 to take the loading of a A-Sail bowsprit
TOPSIDES:	Fair condition – some scratches and chips to the gelcoat
SUPERSTRUCTURE:	Fair condition - some scratching and dents in paint work
DECKS:	Fair condition - the teak is worn as would be expected in a yacht of its age.
EXTERIOR JOINERY:	Fair condition
ANTIFOULING:	Good condition - repainted by RHKYC in 2019
BILGES:	Good condition - all bilges are dry and clean
INTERIOR JOINERY:	Fair condition - some water stain damage to veneers. Varnish work due refreshing

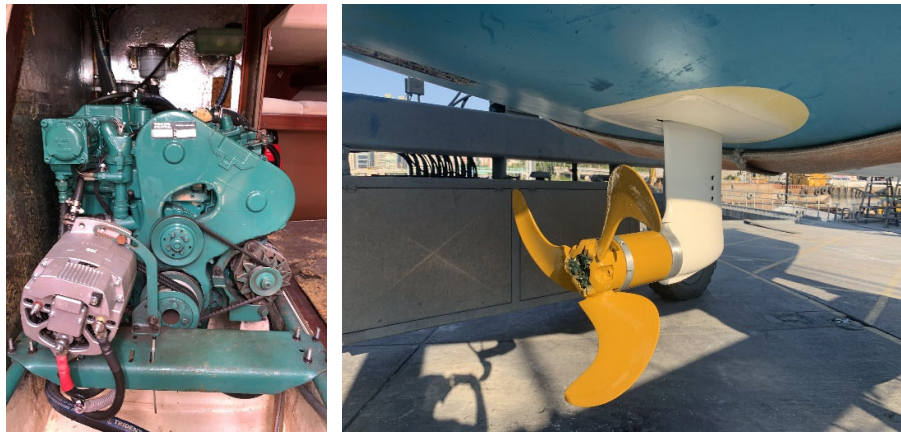
Engine – Sail-drive

MANUFACTURER: Volvo **MODEL:** MD 22 P
SERIAL NO: 5100707064 **HOURS:** unable to determine
TYPE: 4 cylinder water cooled diesel **POWER:** 59 HP
ENGINE OIL: Appears to be in good condition - No samples requested
TRANSMISSION: Volvo Sail-drive (120S) **RATIO:** Not seen
LAST SERVICE: Regularly serviced by owner who is a qualified engineer. Service records have been maintained.

ENGINE ROOM COSMETICS: Fair condition - bilges are essentially clean and dry
ENGINE COSMETICS: Fair condition
CONTROLS: Operable/ Functional - Single lever control Morse cable type mounted starboard side of starboard steering pedestal
INSTRUMENTS: Operable/ Functional - Volvo start panel mounted on starboard side aft of steering pedestal with engine hours, rpm, oil pressure, temperature, warning lights and alarms
FUEL FILTERS: Good condition – 1 x CAV fuel filter system
RAW WATER: Good condition
EXHAUST: Good condition
ENGINE BEDS: Good condition - Hand laminated longitudinal GRP engine beds
ENGINE MOUNTS: Fair condition
EXHAUST SYSTEM: Fair condition – No cracks or leakage sighted in exhaust manifold, muffler or flexible hose
COUPLING: None
STERN GLAND: None
SAIL-DRIVE: Fair condition. Was removed in 11/2016 and hull seal replaced.
PROPELLER: Good condition – New Volvo 3-bladed propeller fitted 03/2018.

MSES recommend regular testing of oil samples to monitor engine and gear box condition.

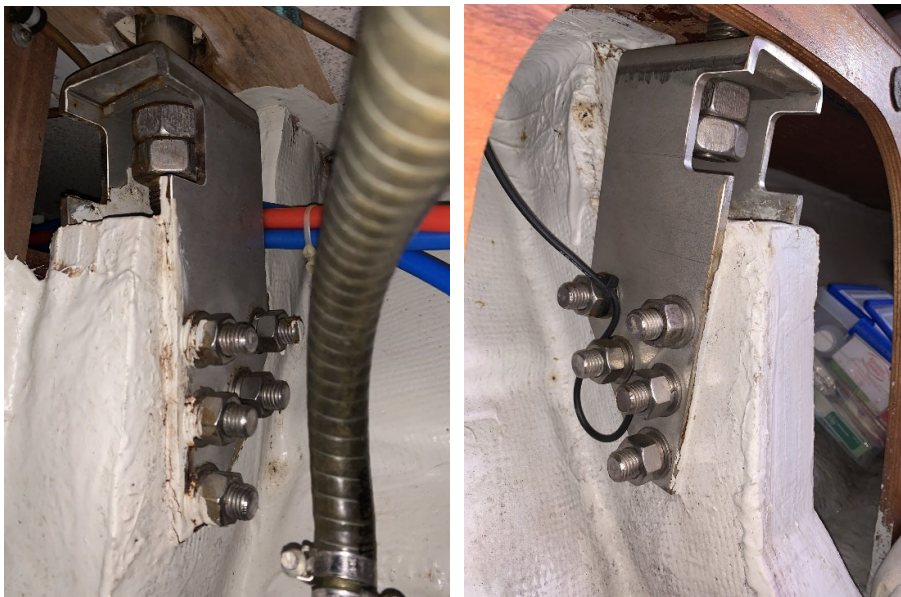
Chainplates (port & starboard)

STANCHIONS:	Fair condition - large diameter stainless steel tube mounted in male spigots in deck
PUSHPITS & PULPITS:	Fair condition - large diameter stainless steel tube mounted in male spigots in deck
STANDING RIGGING:	Fair condition - Original wire standing rigging other than D2s and lower backstay replaced 2017.

RIG INSPECTION: MSES recommends replacement of the remainder of the 20-year-old standing rigging.

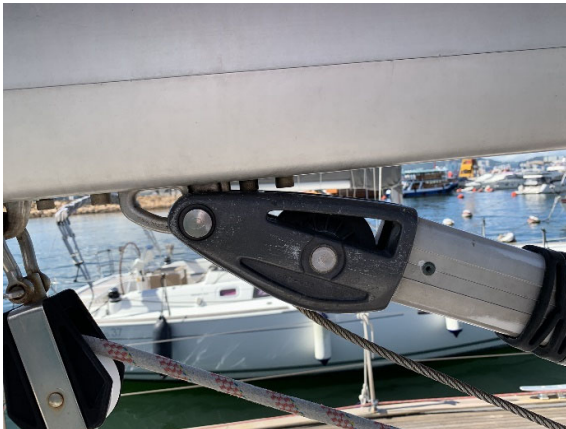
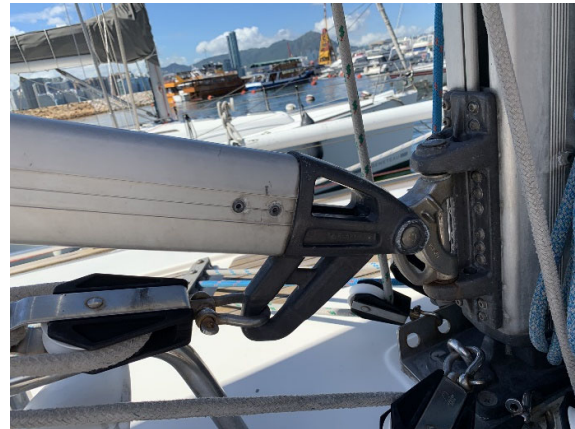
Boom vang attachments at boom and mast

MAST:	Fair condition - Seldon double spreader aluminium mast with in-mast furling
BOOM:	Fair condition – Seldon boom aluminium
GOOSENECK:	Fair condition
MAST STEP:	Fair condition – Coach roof stepped
MAST JACK:	None
SPIN POLE:	Fair condition
BOWSPRIT:	Fair condition
BOOM VANG/STRUT:	Fair condition – Seldon gas strut
MAINSAIL TRACK:	Fair condition
OUTHHAUL:	Fair condition
BACKSTAY:	Fair condition – Seldon manual unit
HEADSAIL ATTACHMENT:	Fair condition – Seldon roller
TRYSAIL TRACK:	None (uses same track as 2 nd mainsail)
RUNNING RIGGING:	Fair condition
CHAIN PLATES:	Good condition
DECK GEAR:	Winches: - Fair condition - regularly maintained by crew. 2 Self tailing Harken 56 electric genoa sheet winches 1 Self tailing Harken 33 secondary winch 1 Lewmar 40 winch 2 Self tailing Harken 44 mainsheet & halyard winches Deck hardware – Rugerson & Lewmar - regularly maintained by owner
LIFELINES:	Good condition – Dyneema ties replaced 11/2019
